Fonterra Hautapu Resource Consent Compliance Annual Report

1 July 2019 to 30 June 2020

**Fonterra Hautapu
Annual Resource Consents Report
2019/2020**

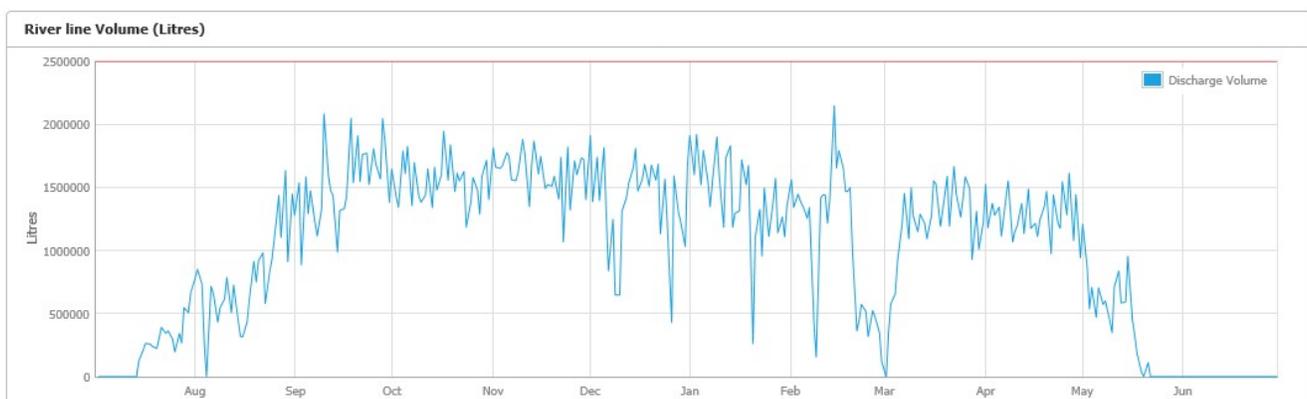
Figure 1 Volume Discharged to Waikato River

Generally, the volumes discharged were well below the consent limit. A set-point is entered into a system to ensure the volume that is discharged will not exceed 2500 m³ per day. The maximum volume discharged was 2,148 m³/day on 14 February 2020.

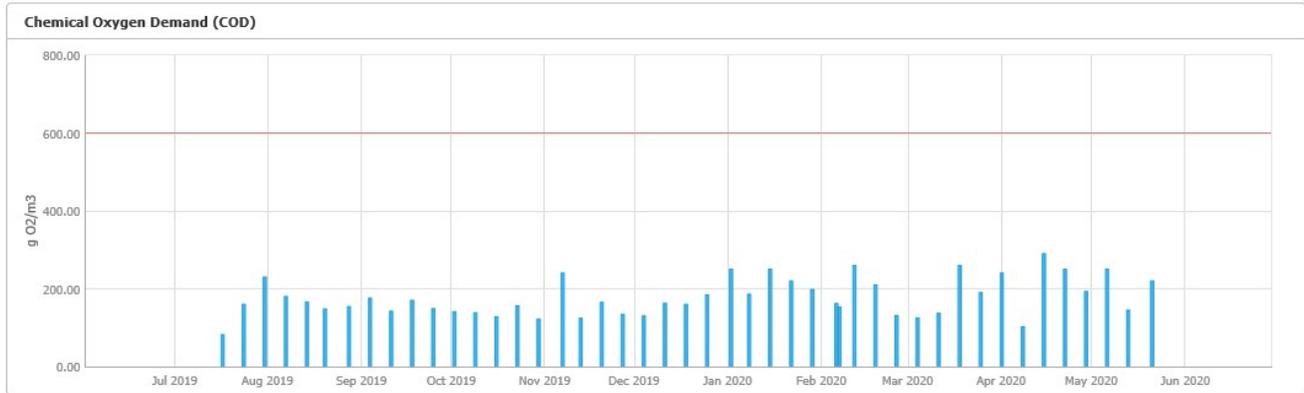
Figure 2 COD Levels in the River Discharge

A weekly sample of the river discharge is tested by Hill Laboratories for Chemical Oxygen Demand or COD. The results from this testing are used to calculate COD loads.

The graph shows that the 10-day rolling average stayed well below the consent limit of 600kg per day for the rolling average.

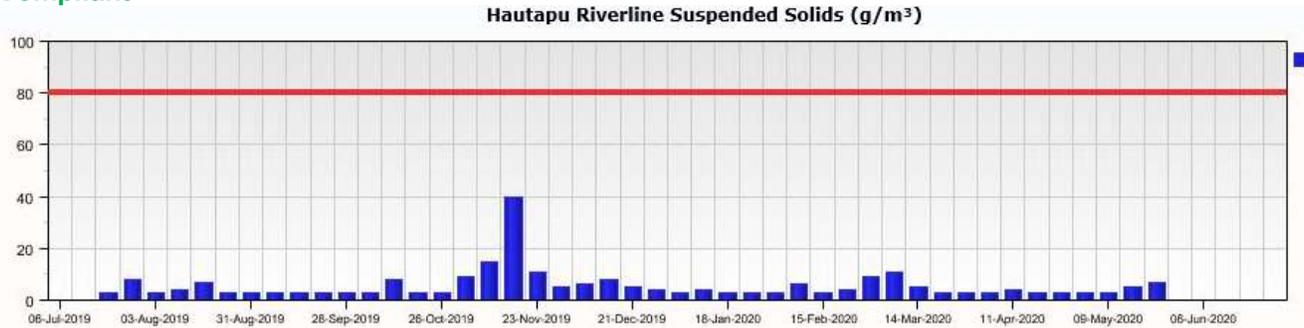
Figure 3 Suspended Solids Levels in the River Discharge

Suspended solid concentrations remain low and considerably below the consent limit.

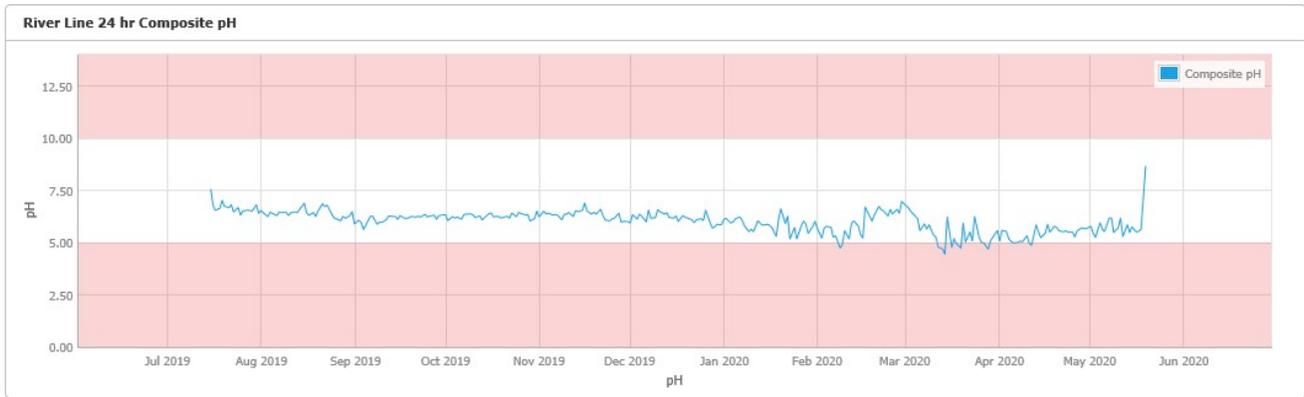
Figure 4 pH of the River Discharge

The graph shows most results to be within the limits. The drop in the pH in February / March to below the limits has been reported to WRC as an ENCR and is part of Section. 7, Non-Compliance Summary. The missing data on the shoulders of the graph is due to season shut periods.

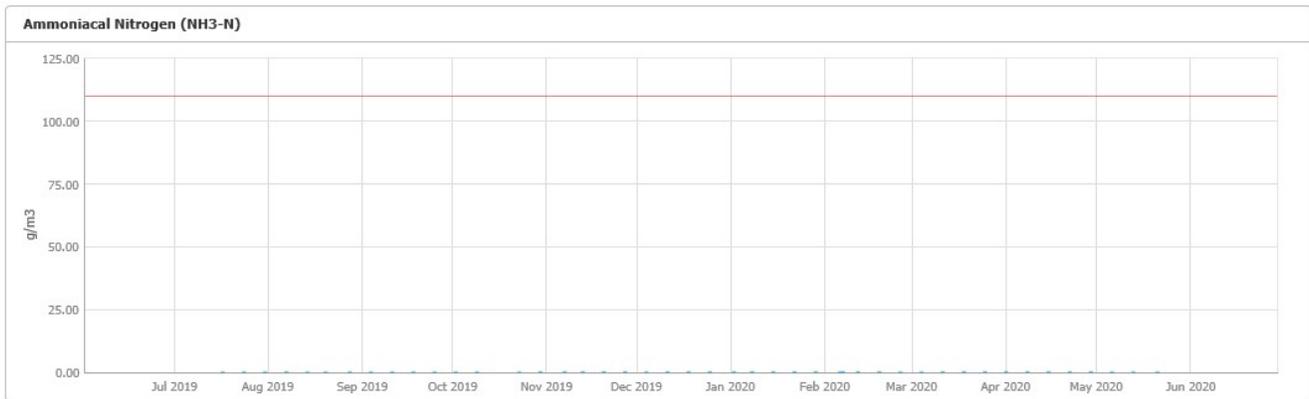
Figure 5 Ammonium-N levels in the River Discharge

Ammonia levels during the season have again been well below the consent limit. All results have been below the detection limit for the tests and show as zero in the graph.

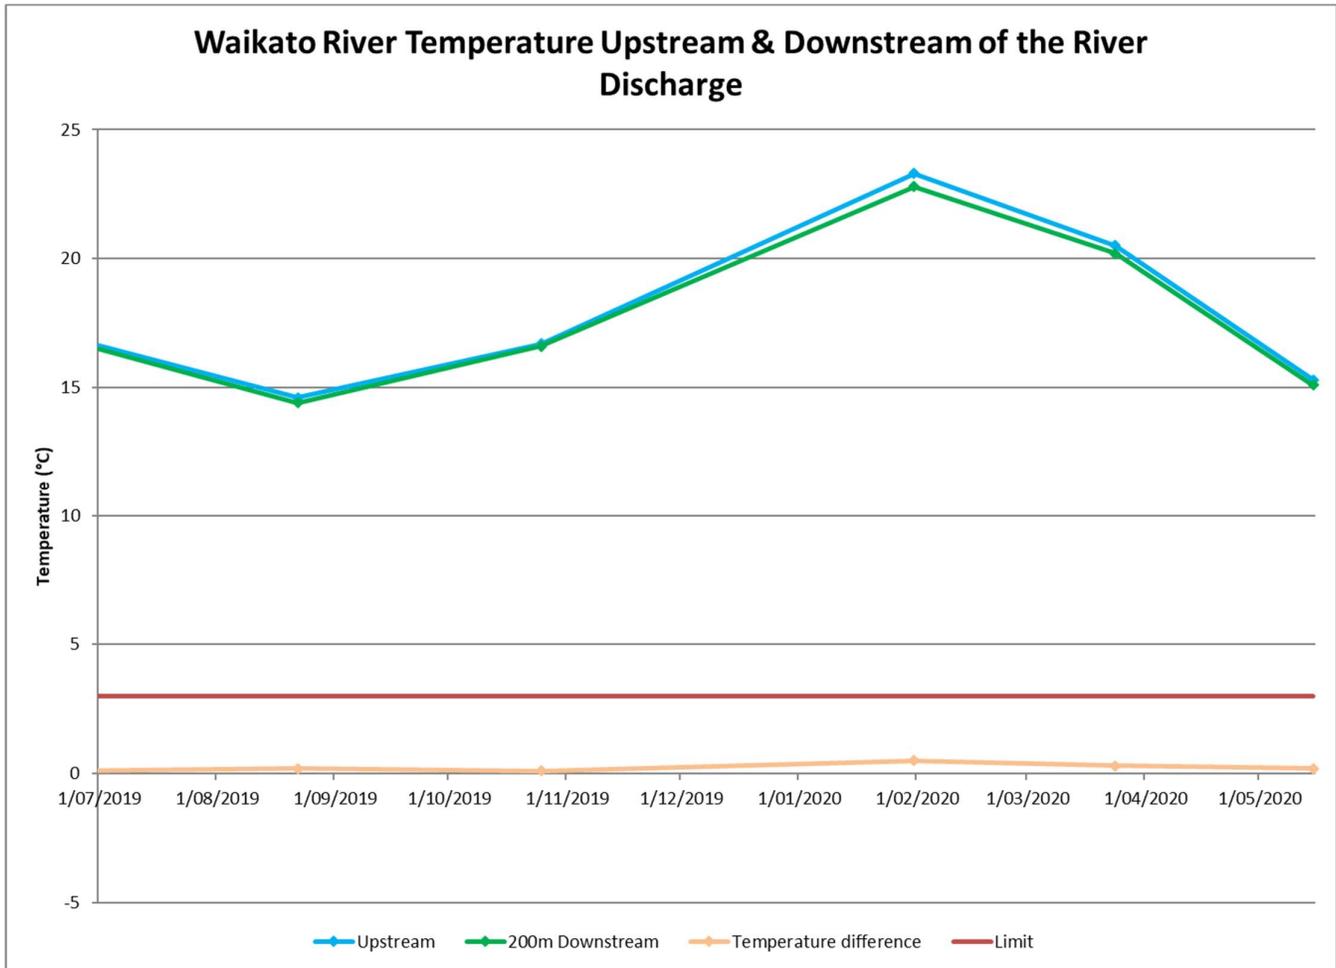
Figure 6 Waikato River Temperature Readings Up and Downstream of the River Discharge.

Temperatures were measured from the river by boat, the largest difference measured was a decrease of 0.5°C (downstream compared to upstream) and all temperatures were below the maximum temperature consent limit 25°C. The highest temperature measured was 23.3°C on 31st January 2020.

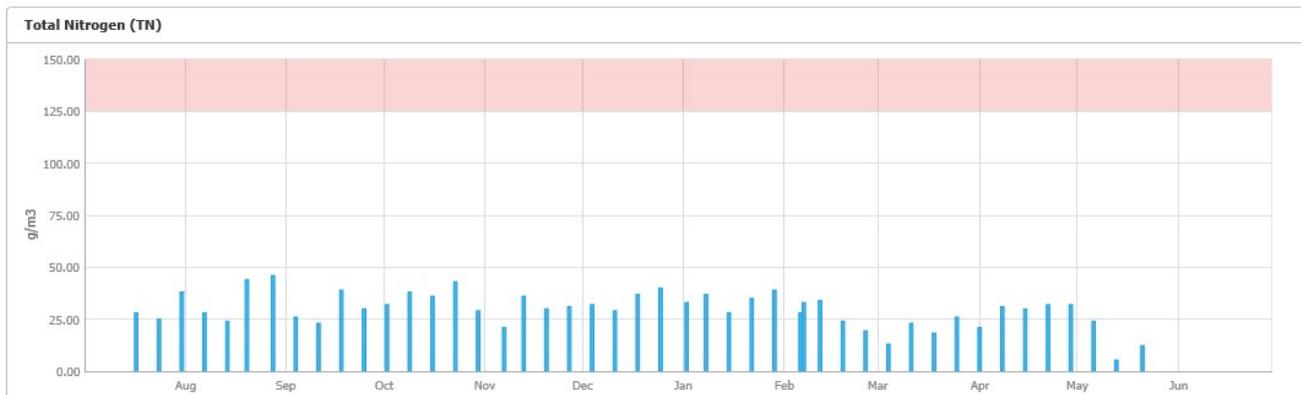
Figure 7 Quarterly Nitrogen Load to Waikato River

The average quarterly total nitrogen (based on TKN + NO₃-N + NO₂-N concentrations) in the wastewater discharged to the river were below the maximum limit of 125kg per day.

Results above show good compliance with the resource consent limit for nitrogen load. The results are in-line with previous season results.

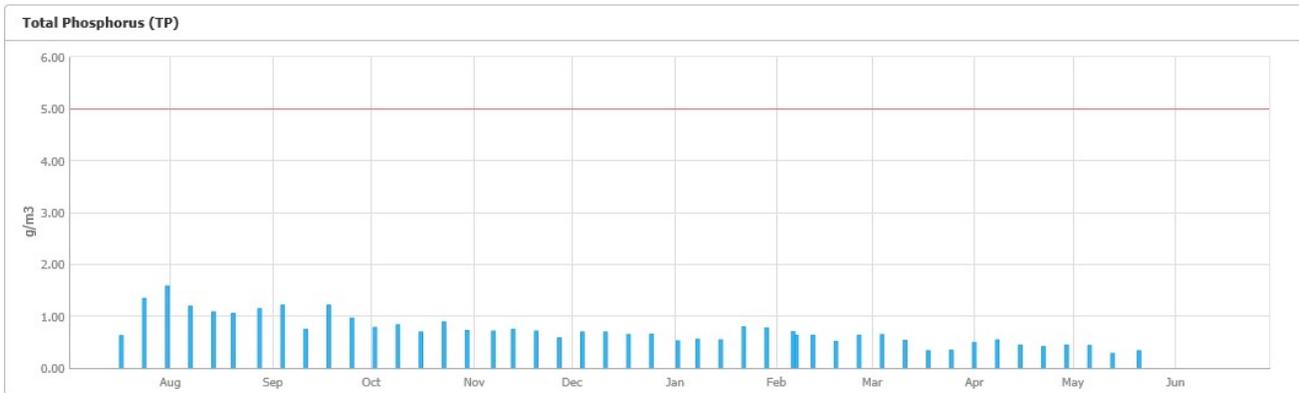
Figure 8 Quarterly Phosphorus Load to Waikato River

The average quarterly total phosphorus in the wastewater discharged to the river was below the maximum limit of 5kg per day.

The actual quarterly phosphorus loads are well below the consent limit and in line with what was measured the previous season.

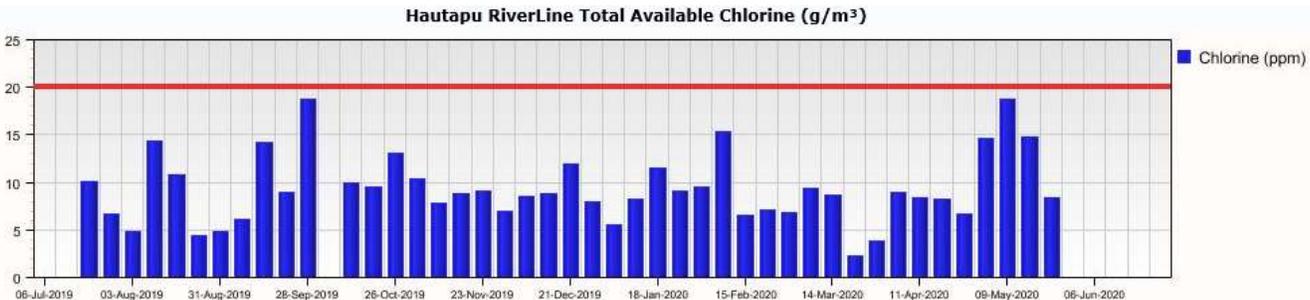
Figure 9 Total Available Chlorine in River Discharge

Grab samples were collected weekly from the river pipeline end and tested for total available chlorine. The average as a 3-month rolling average did not exceed 20g/m³.

Total Available Chlorine was measured by the site operators using the Orbeco Hellige Analyser.

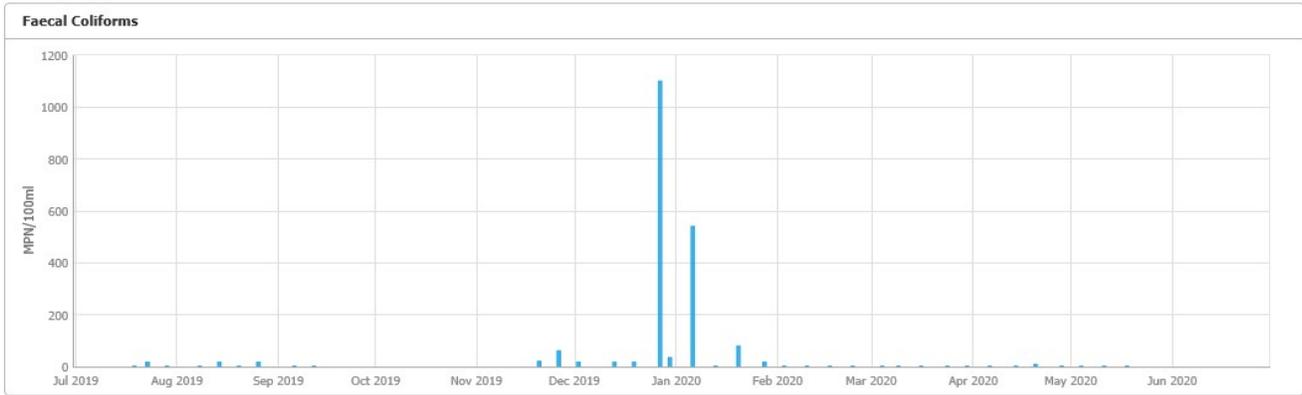
Figure 10 Faecal Coliforms in River Discharge

Grab samples from the discharge pipe end were sent on a weekly basis to Hill Laboratories in Hamilton for faecal coliform testing.

The residual chlorine in the discharge during the season was again neutralised with sodium thiosulphate prior to testing to get a better indication of the presence of faecal coliforms. There has been a couple of spikes in the results. It was established that the sample point had a rubber fitting that was contaminated due to the nature of the material. Some dirt had accumulated and caused the high reading. The rubber fitting has been changed to a stainless tap and can be efficiently sanitised before sampling.

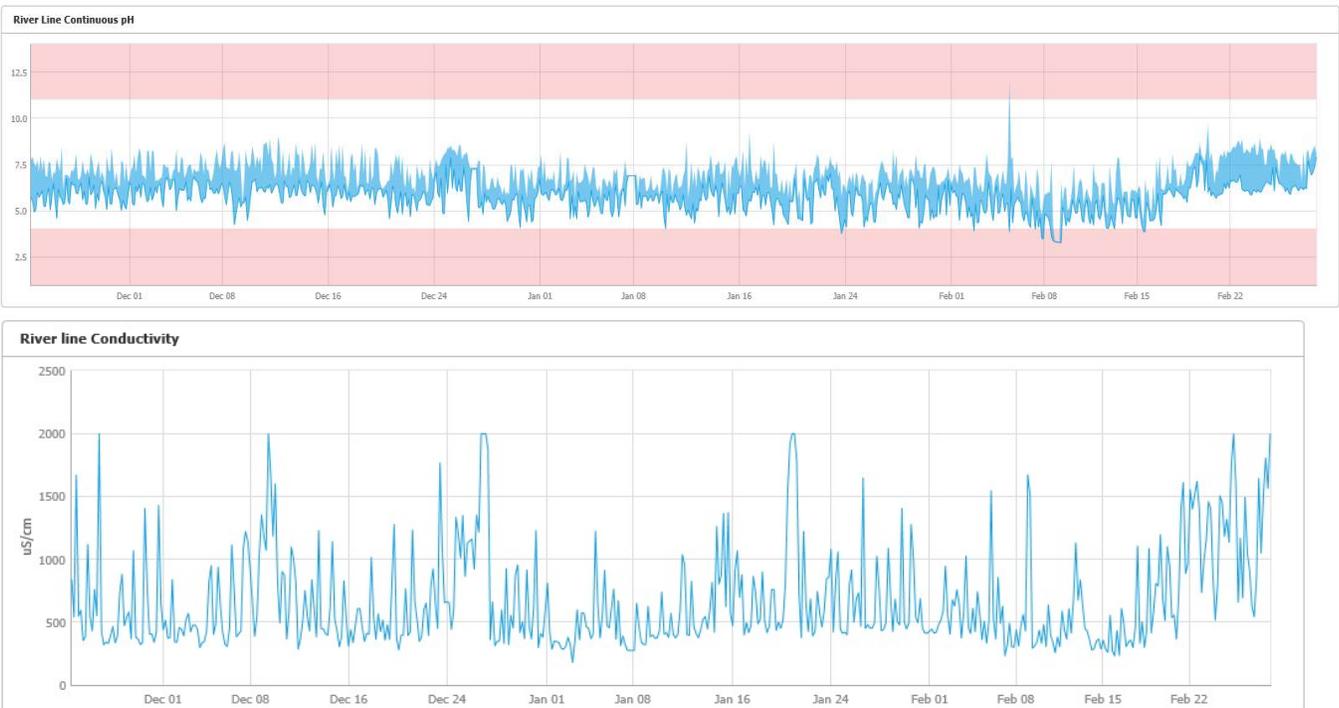
Figure 11 Continuous monitoring for pH and Conductivity on the River Discharge

Inline pH and conductivity probes are installed to allow continuous monitoring of these parameters. The volume of wastewater discharged is measured through a flowmeter installed in the pipeline at the factory site. The 24hr discharge volume is automatically recorded through the PLC.

Below is an example of the continuous monitoring for pH and conductivity from November 2019 to February 2020.

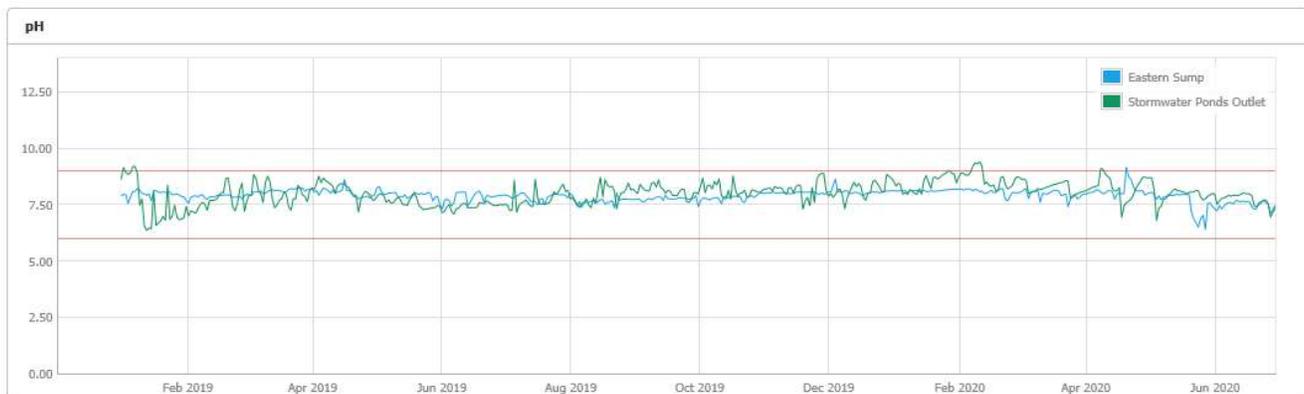
No stormwater discharges were outside of the pH limits. The pH is monitored and shows some values above pH 9. This was due to excessive algae growth on the stormwater pond and water circulating through the tundish continuously as part of monitoring. The gate valve has been shut during this time and no discharge could take place.
