CAMBRIDGE, HAUTAPU, PROPOSED WASTEWATER TREATMENT FACILITY AND ASSOCIATED INFRASTRUCTURE: PRELIMINARY ARCHAEOLOGICAL ASSESSMENT

Prepared for Fonterra Cooperative Group Ltd

May 2021

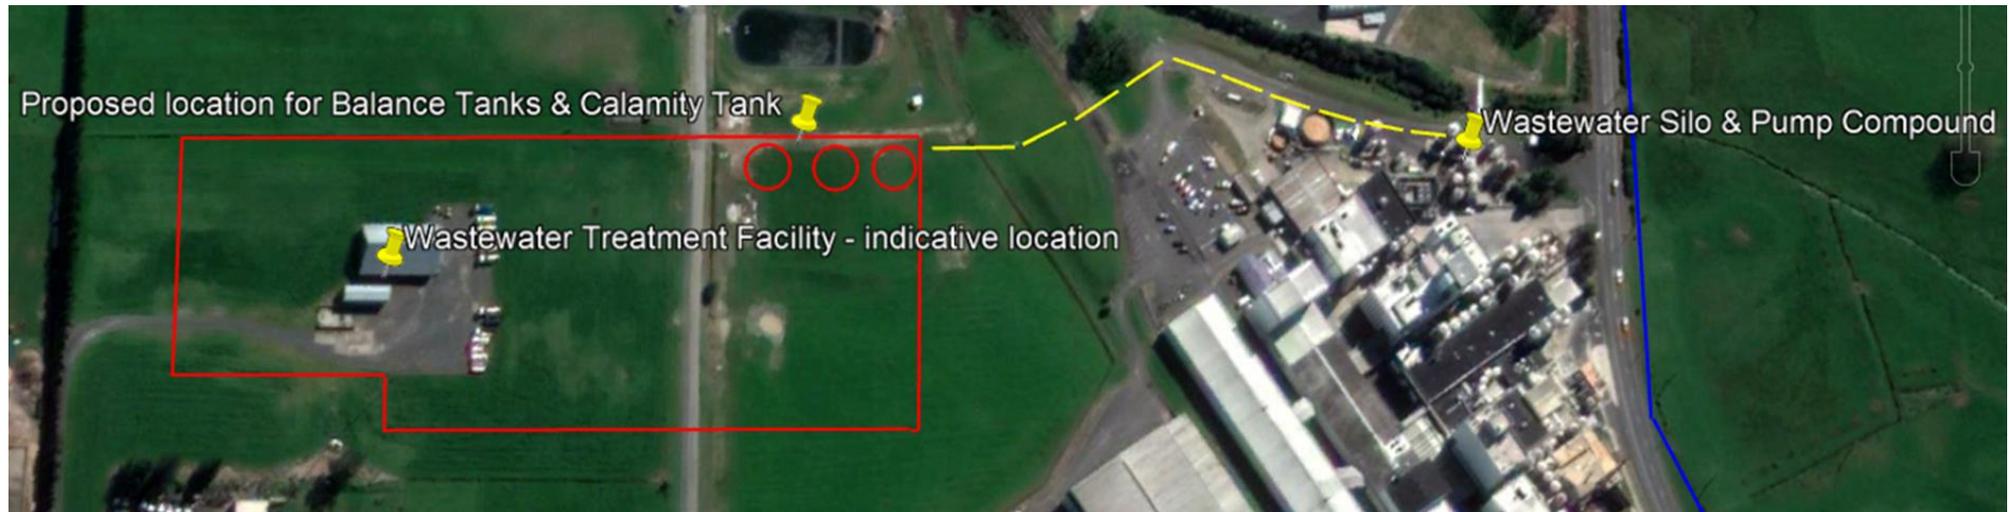
Figure 2. Conceptual layout plan for the proposed WWTF, Balance and Calamity Tanks and pipeline connection to existing wastewater storage facility (source: PDP)

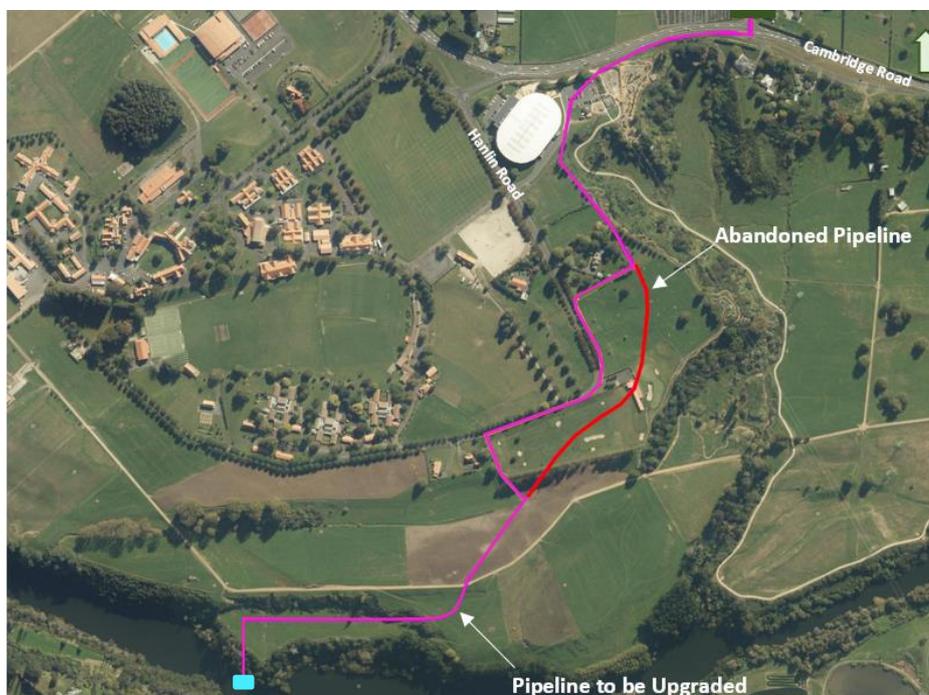
Figure 4. Aerial plan showing the existing riverline pipeline alignment to be upgraded (purple line) and abandoned pipeline (red line) with diffuser location indicated by blue rectangle – to the south of Cambridge Road (source: Fonterra)

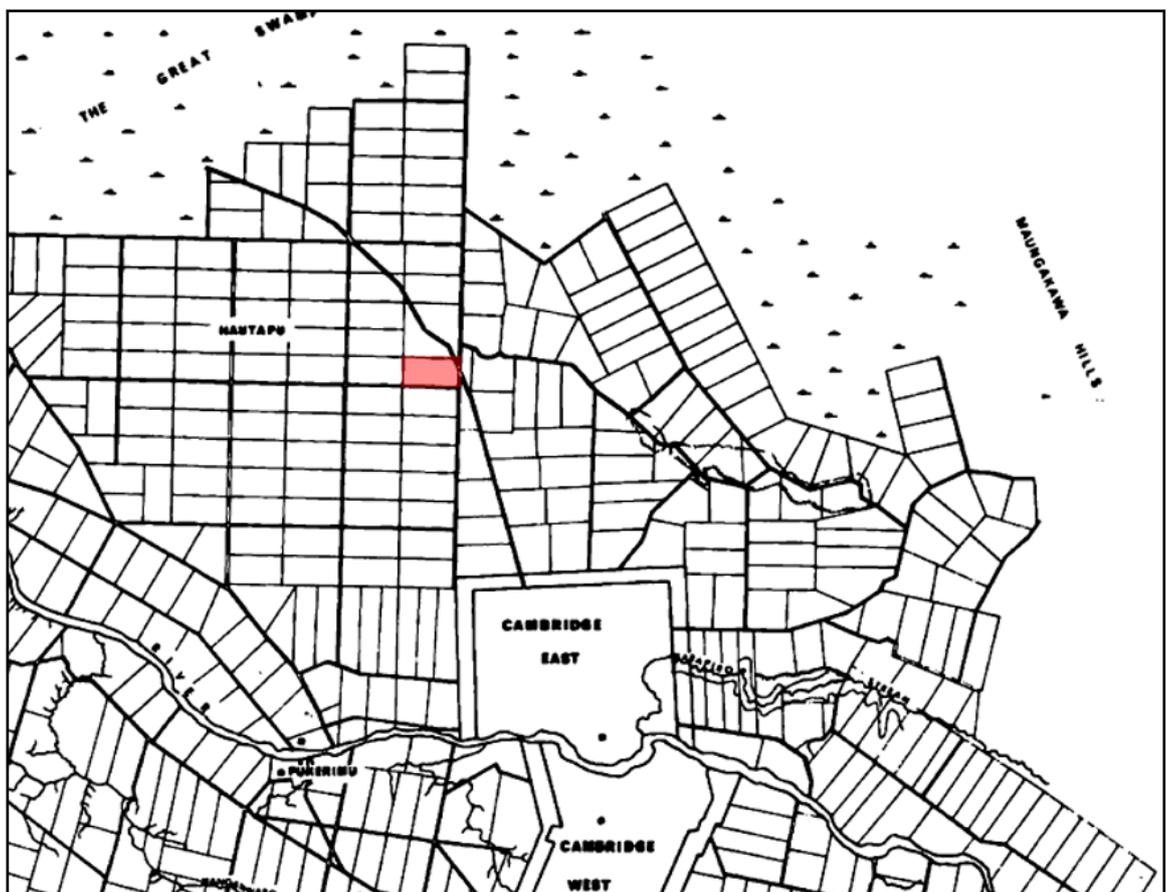
Figure 5. Plan of the militia farm allotments around Cambridge with the lot containing the location of the proposed WWTF shaded red (source: Allen 1969)

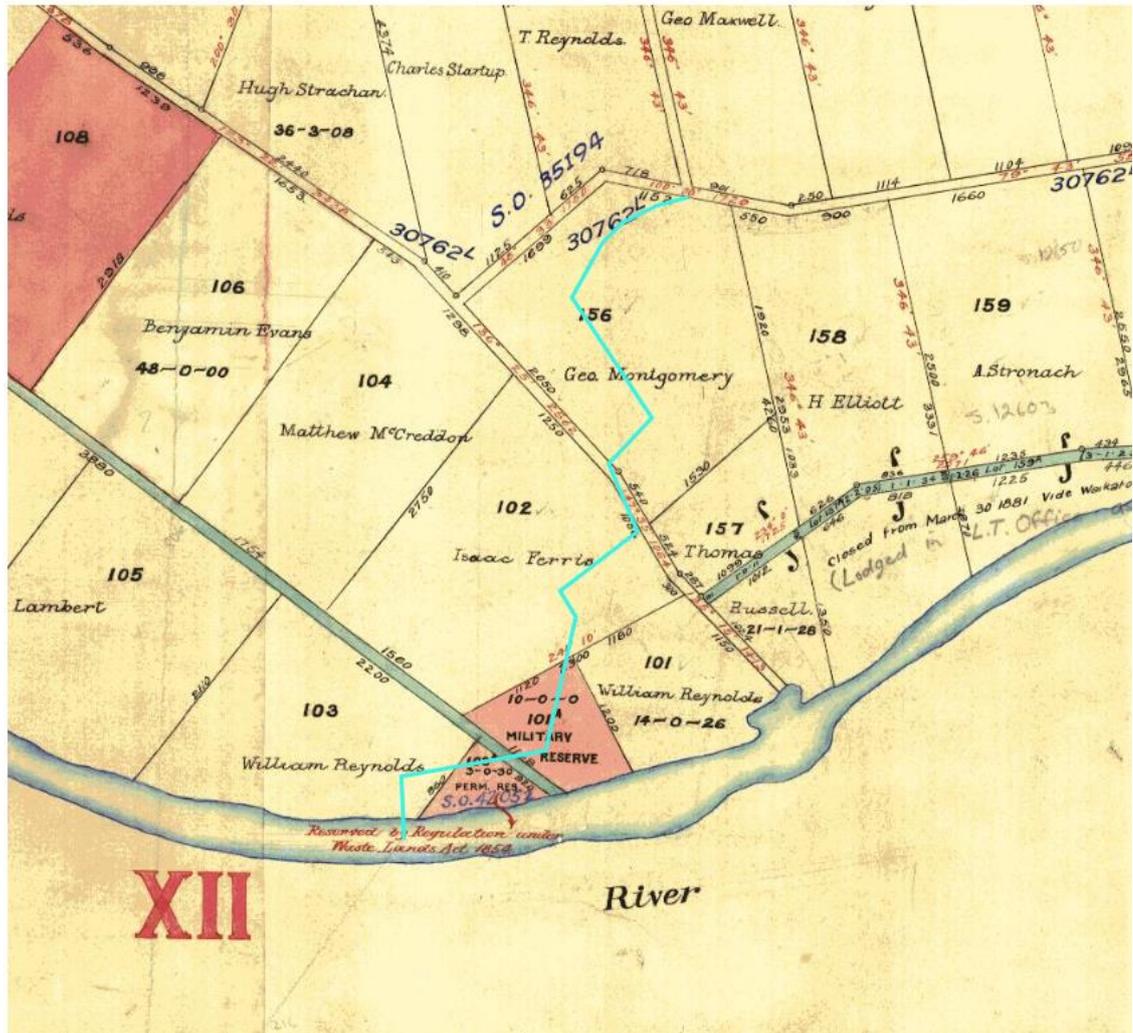
Figure 10. Detail from HNC SO 96 3 (no date) entitled 'Plan of Waikato Military Settlement Pukerimu Parish of Hautapu' with estimated alignment of the riverline pipeline upgrade shaded in blue (source: Quickmap)

The area between Cambridge Road and the Waikato River contains the southern part of the existing pipeline which connects to a diffuser which is situated in the river. The land in this area was also granted to the men of Third Waikato Militia. As can be seen in the undated plan in Figure 10, the riverline pipeline passes through allotments with the names George Montgomery (Lot 156), Isaac Ferris (Lot 102) and William Reynolds (Lot 103). George Montgomery was born in Ireland in 1839 and enlisted in the 3rd Waikato Militia in 1865 as a substitute soldier (Private) and his occupation was listed as labourer. He owned the property in 1870 as he was listed in the rates assessment for 1869-70 (Cambridge Museum Website). Isaac Ferris is listed as being in the Third Waikato Militia, but additional information was not found during the research for this report. As noted above, Lot 103 has the name William Reynolds annotated. Reynolds received his military grant elsewhere and later added Lot 103 to his land holdings. He died at the young age of 29 in 1872 from a fall from his horse and his father inherited his land (Cambridge Museum Website).

The plan in Figure 10 also shows the presence of two reserves in this area, both bordering the Waikato River. The larger of the two is labelled Military Reserve and is the location of the former Pukerimu Redoubt. This was one of two redoubts built on opposite sides of the Waikato River and both locations also included landings. The main redoubt was on the southern side of the river and was used by General Cameron as his headquarters. The northern redoubt was established in late March 1864. The redoubts were garrisoned by soldiers of the 18th and 70th Regiments who were later replaced by colonial forces. The plan in Figure 9 shows the two redoubts at Pukerimu with the southern one labelled 'Cameron's Redoubt' (NZZA Site Record S15/99). A small triangular-shaped parcel of land (101A) is located just to the west of the military reserve with 'Perm. Res.' and 'Reserved by Regulation under the Waste Lands Act 1854' annotated for 103A in Figure 10. The Wastelands Act dealt with issuing of Regulations on the sale and disposal of unused (wastelands) Crown lands. A later survey from 1962 in Figure 14 also shows a survey plan of this reserve.

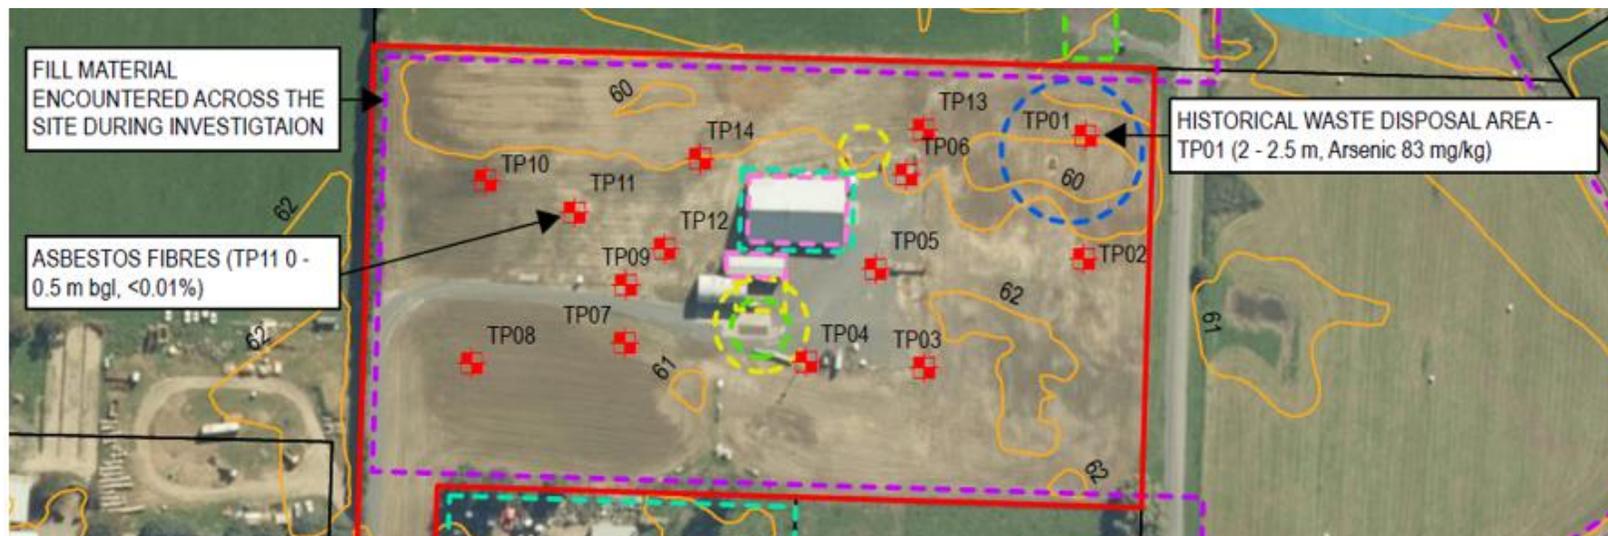
Figure 21. Upper -Aerial plan showing the locations of geotechnical test pits in the proposed WWTF site (source: PDP Ltd) and lower Aerial photographs showing the past impacts on the proposed WWTF site: from left to right, 1971 (Crown 3470 4512 21), 1979 (Crown 5479 H 27) and 1995 (Crown 9401 E7) (sourced from: <http://retrolens.nz> and licensed by LINZ CC-BY 3.0)

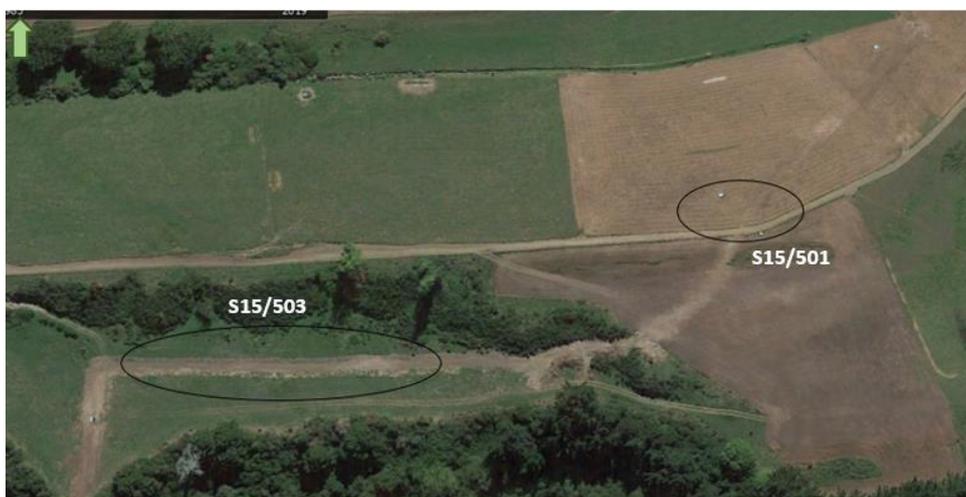
Figure 23. Aerial photograph dated 2016 showing works from installation of the riverline pipeline trench in the southern part of the alignment with general location of borrow pits identified by black circles at recorded archaeological sites S15/501 and S15/503 (source: Google maps)

The aerial photograph in Figure 23 shows ground disturbance from excavation works for the southernmost section of the riverline pipeline. As can be seen this runs through two areas where borrow pits have been recorded at S15/501 and S15/503. It is noted that the area containing S15/501 has been used for crop cultivation and the construction of an access track, which has obscured any surface evidence of the recorded borrow pits.

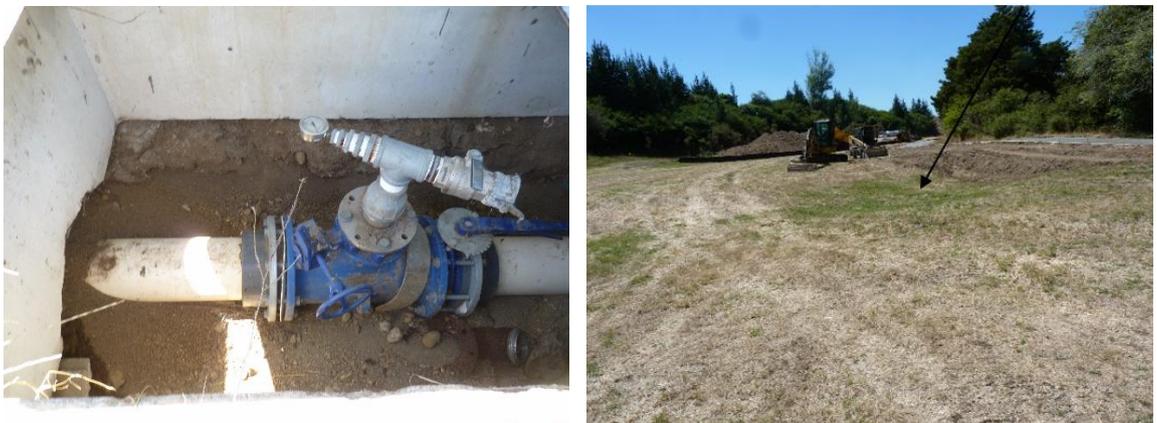
Figure 24. Left photograph showing the existing pipe in manhole that was inspected; and right photograph with borrow pit (S15/503) identified during the site visit indicated by arrow and stockpile associated with works for the Cycle River Ride project visible in the background, looking east

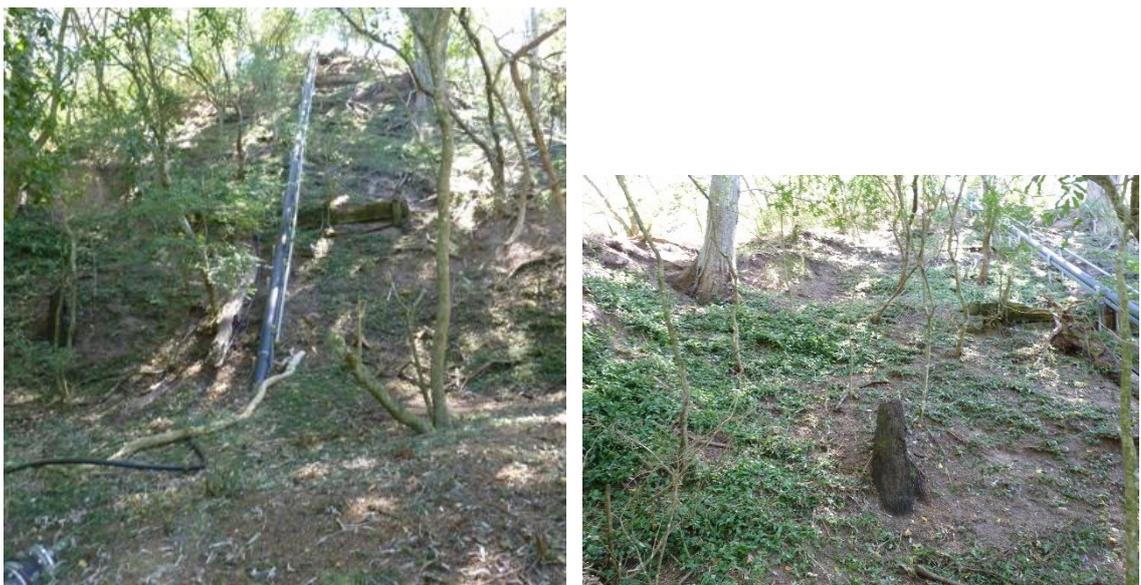
Figure 25. Photograph showing the riverline outfall pipe, looking north and detail of the slope containing the existing outfall pipe looking northeast

The hillside containing the outfall pipe was also inspected. The hillside contained a number of mature trees and also had large areas of exposed soil and evidence of erosion was observed (Figure 25, Figure 26). The pipeline itself is supported by a metal frame with footings drilled into the soil. The section of pipeline at the bottom of the hillside is located under the ground surface entering directly into the river where the diffuser structure is located (Figure 26, right). No archaeological features or deposits were observed in this area.

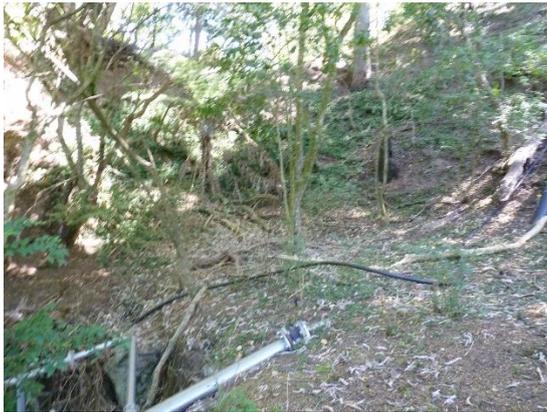
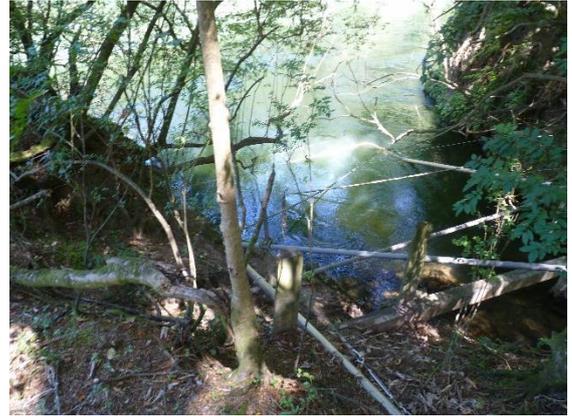
Figure 26. Left photograph showing the base of the outfall pipe where it joins up to the diffuser, looking northeast and right photograph showing the diffuser structure in the river, looking south

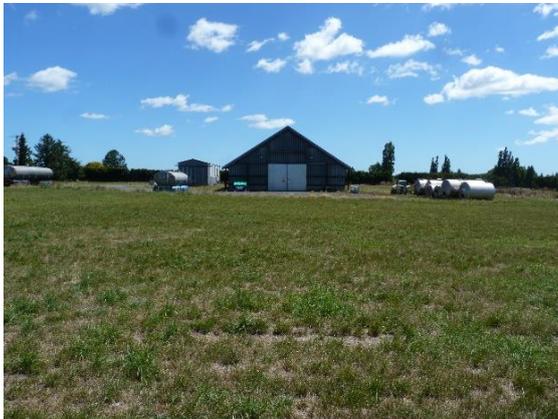
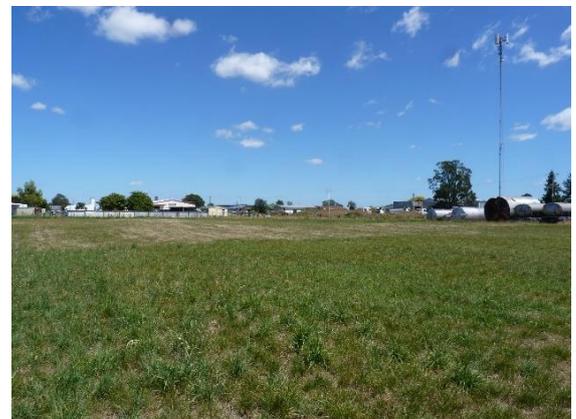
Figure 27. Left photograph showing the remaining structures at the proposed WWTF location, looking east; and right photograph showing levelled area planted in grass with telecom mast indicated by arrow, looking southwest

The proposed WWTF site was visited next. The entrance to the property is located on Hautapu Road and a gravelled driveway is situated on a narrow strip of land leading north to where the main part of the property (and the proposed WWTF site) is located. The area was observed to be a rectangular shaped lot containing a large storage shed and several smaller outbuildings (Figure 27). A telecommunications mast that will remain in its current location was also noted (Figure 27, right). The ground surface around the buildings was

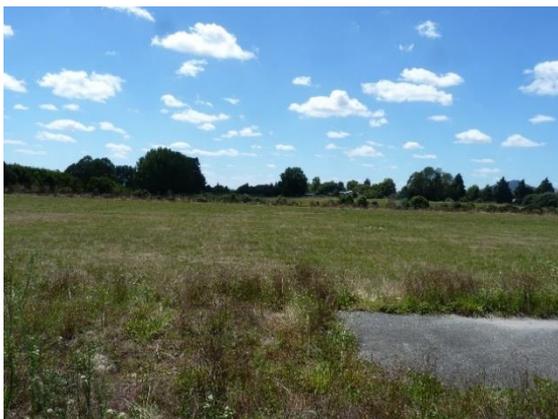
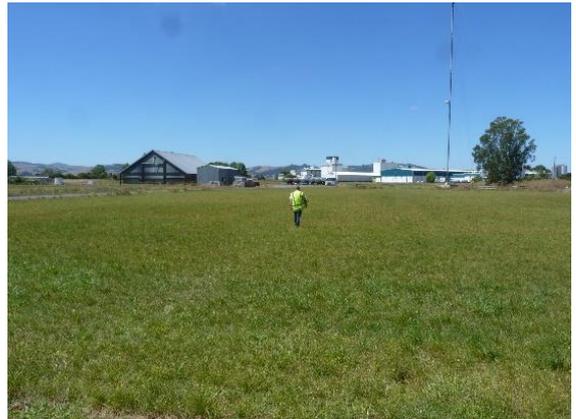
Figure 28. Left photograph showing general view of the northern part of the proposed WWTF site looking north; and right photograph showing general view of the southern part of the WWTF site looking east

covered by gravel or concrete. The remaining land had been ploughed and the land had been levelled out with fill (Figure 27, Figure 28). Most of this land had been planted in grass which was quite sparse over most of the property. No archaeological features or deposits were observed during the site visit. The area containing the proposed calamity/balance tanks and pipeline connection to the existing wastewater facility contained a grass paddock at the time of the survey and no evidence of archaeological deposits or features was identified.

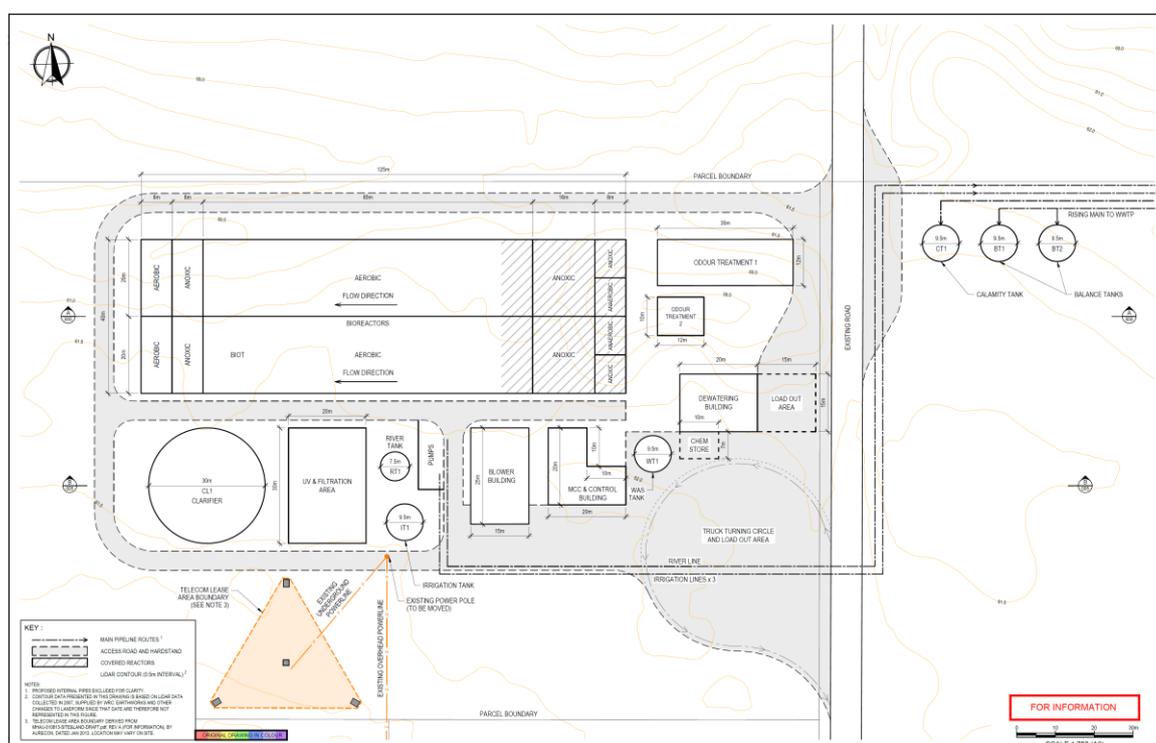
Figure 29. Plan showing the conceptual layout of the proposed WWTF and Calamity and Balance Tanks (source: PDP)

No archaeological sites have been previously recorded in the proposed WWTF property (Lot 1 DPS 13529) or in the neighbouring property (Lot 3 DPS 13529) proposed for the installation of calamity and balance tanks and a new pipeline to connect the proposed WWTF to the existing wastewater storage facility. Past impacts from farming and industrial activities have obscured surface evidence and would have damaged or destroyed any archaeological remains in the upper levels of the soil. Although, the research and survey for this assessment has not identified any archaeological sites in this area, the fact that these properties lie approximately 70m to the south of the Mangaone Stream and a reported historical trackway means the possibility of archaeological remains being present at deeper levels cannot be completely discounted. It is also noted that the proposed pipeline connecting the calamity and balance tanks to the existing wastewater storage facility also passes through the northern end of the old railway reserve and it is considered possible that subsurface archaeological remains associated with the railway may be present. The conceptual plans for the WWTF site are shown in Figure 29.

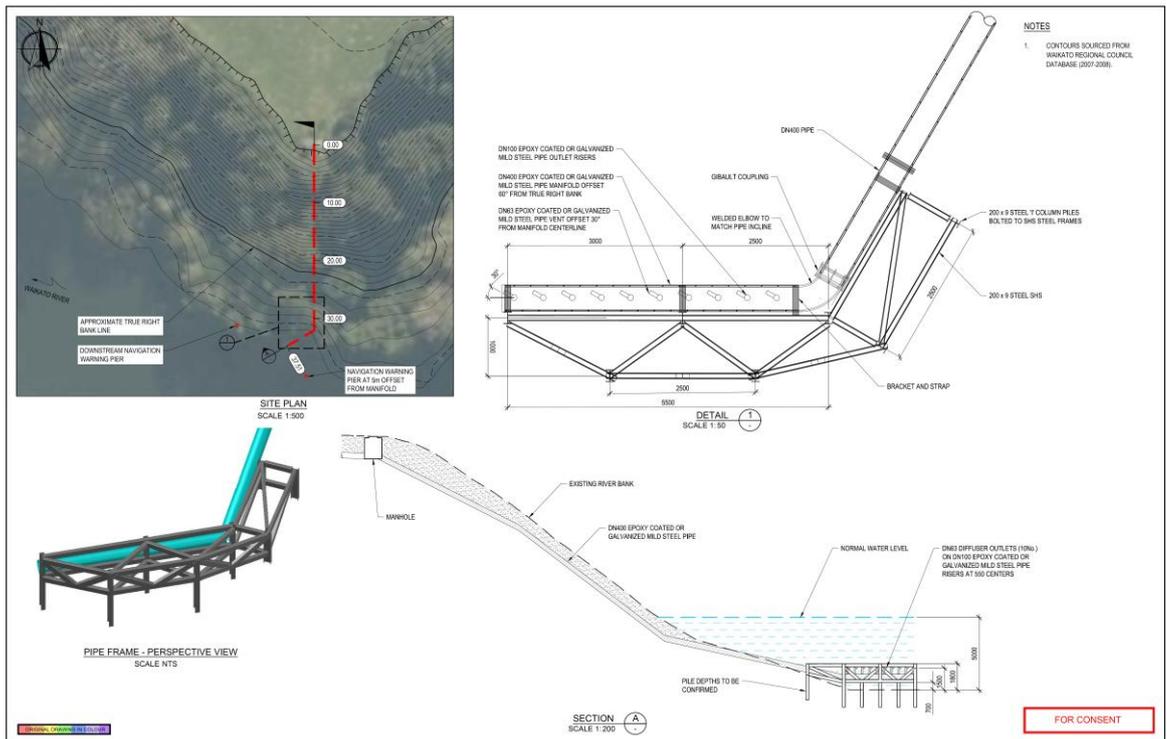
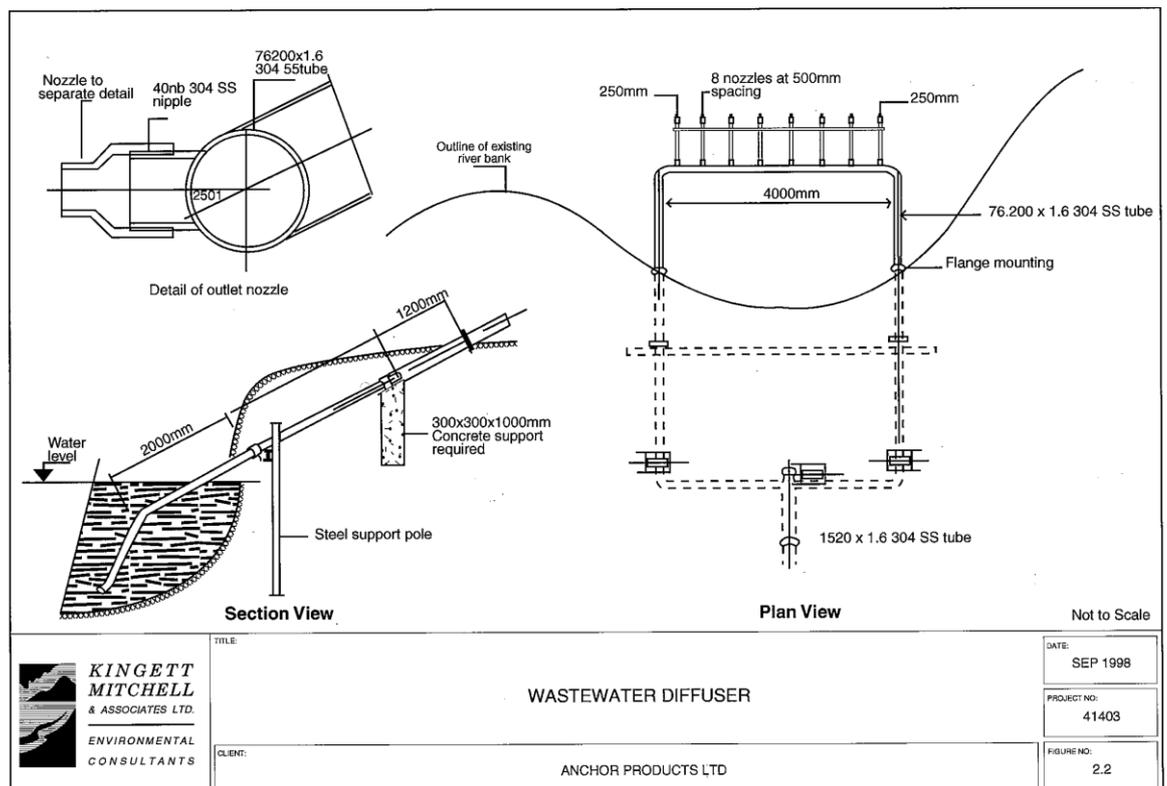
Figure 31. Upper plan showing the proposed outfall and lower plan showing the proposed replacement diffuser (source: upper – PDP and lower – Kingett Mitchell)

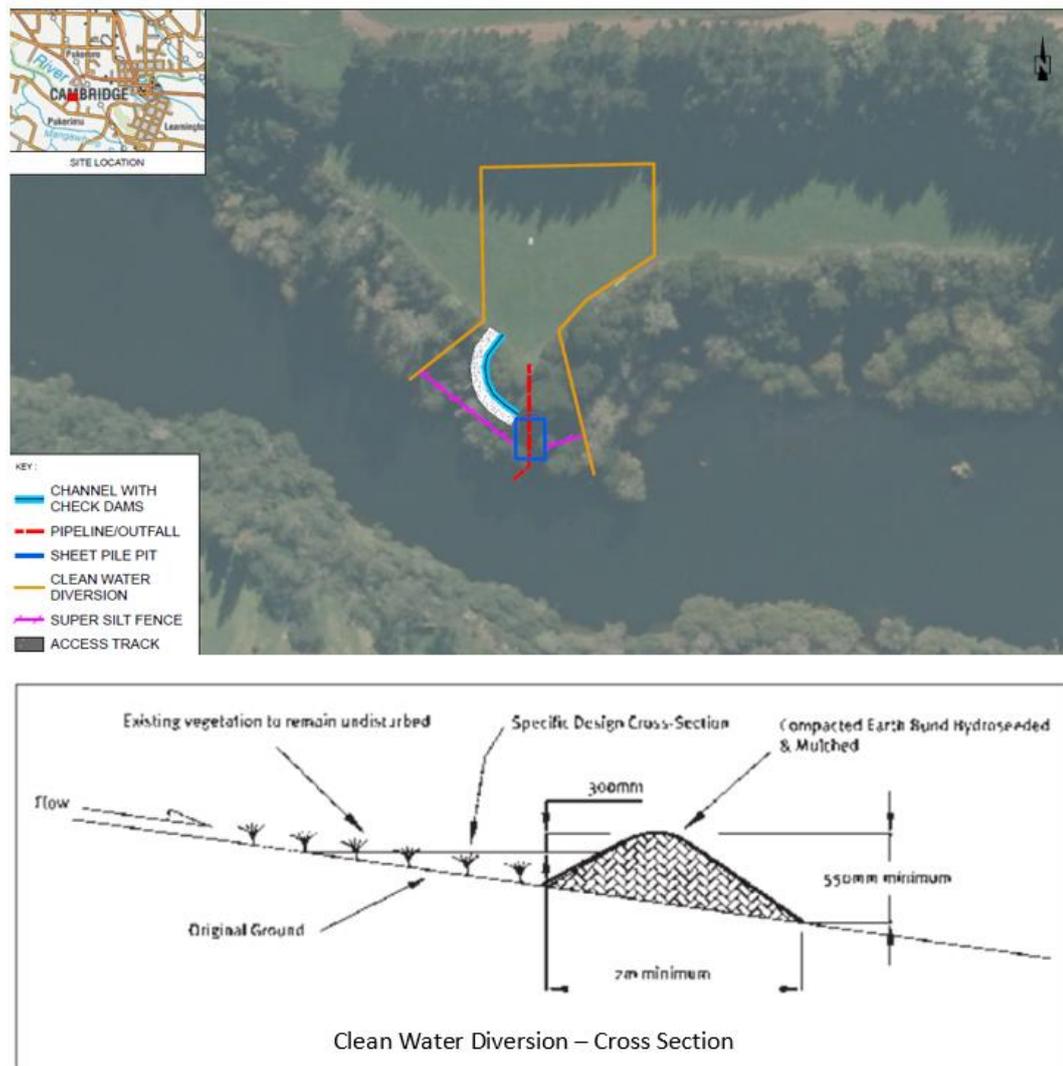
Figure 32. Erosion and sediment control plan (upper) and cross section of the clean water diversion (lower) at the outfall location (source: PDP)

Silt control measures are proposed as shown in Figure 32. The works will include a clean drain diversion (no excavation required) and sheet piling for dewatering along the edge of the river (in an area where archaeological remains are not considered likely to be present). As the works will include the area containing archaeological site S15/503, it is recommended that the extents of any identifiable borrow pits are marked out by temporary fencing during the works to protect them from the damage by machinery and equipment.

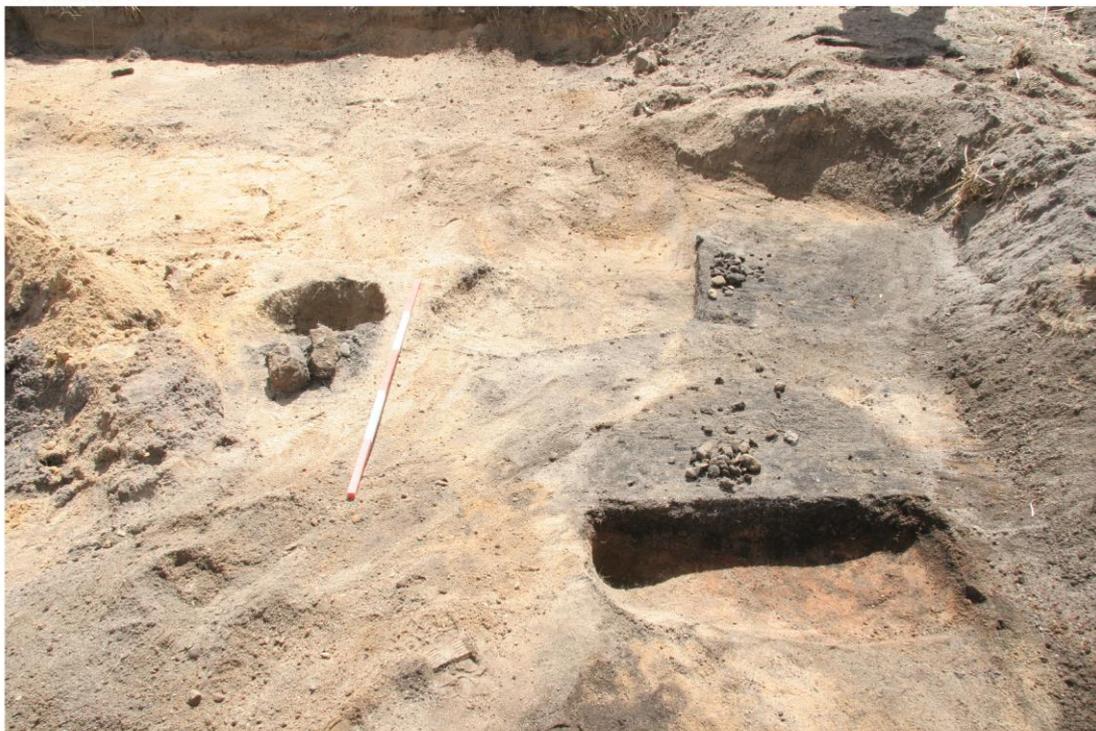
Photograph of the 3 x half sectioned firescoops found during the earthworks on the NE portion of the northern most transmission tower.

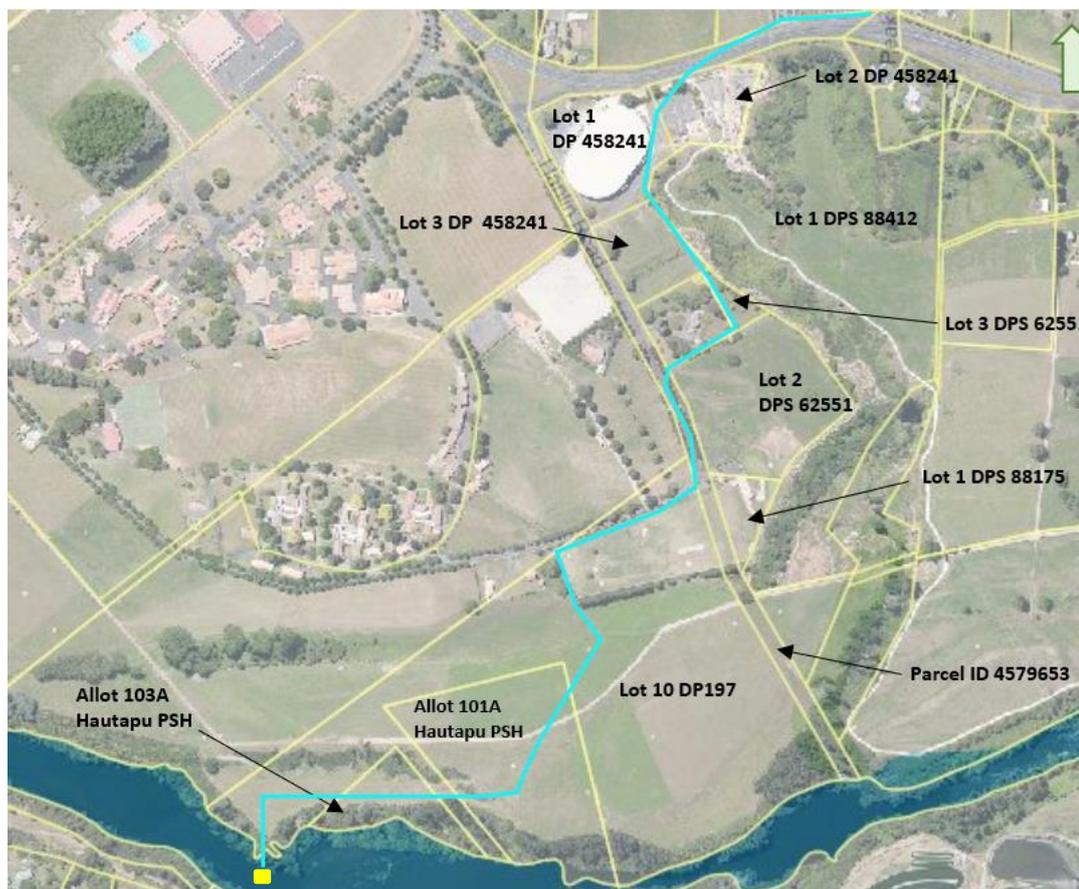
Plan showing the Area to the south of Cambridge Road with pipeline indicated by blue line and diffuser by yellow square (source: Waipa District Intramaps)

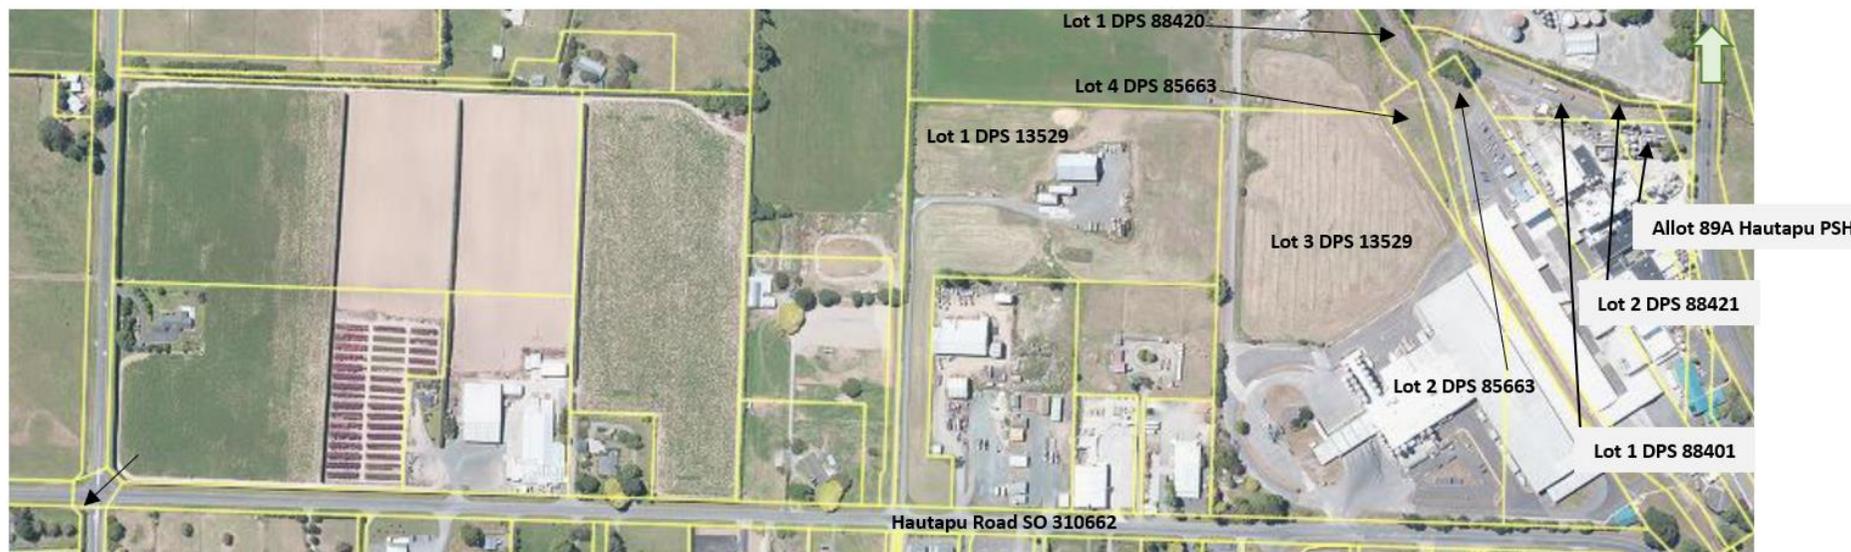
Plan showing the location of existing Fonterra Dairy Factory, proposed WWTF site in Lot 1 DPS 13529 and property containing the balance and calamity tanks and pipeline connection to existing wastewater and silo pump compound included (source: Waipa District Intramaps)
